# ARROYO VIEJO CREEK / KNOWLAND PARK

## OAKLAND, CALIFORNIA

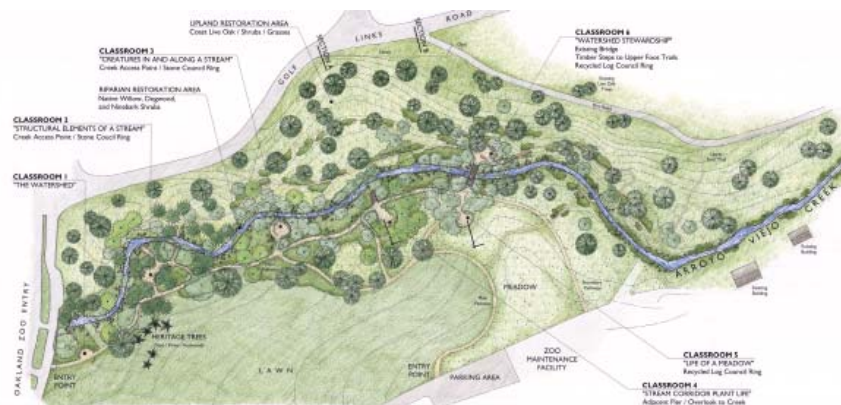
- 01 Park Plan
- 02 Outdoor classroom
- 03 Path through grassland
- 04 Exploring the creek using the creek side steps

The Restoration Design Group was commissioned to complete the design of an environmental education program and restoration plan for the riparian and hill slope areas of the site. RDG developed a complete restoration plan that transforms the hill slope into a native oak grassland, and the creek into a native riparian corridor.

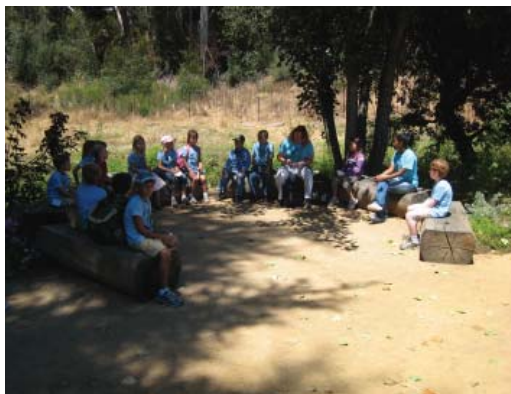
Traveling along a crushed stone path, individual visitors and students enter a series of classrooms of stone and recycled eucalyptus logs to learn about stream processes. The pathway and classrooms form a border between the traditional picnic grounds of Knowland Park and the natural park setting of Arroyo Viejo Creek.
